**Flood Control Project Maintenance
Levee Inspections**

Fall 2012 Levee Maintenance Deficiency Summary Report

Reclamation District No. 0900 West Sacramento

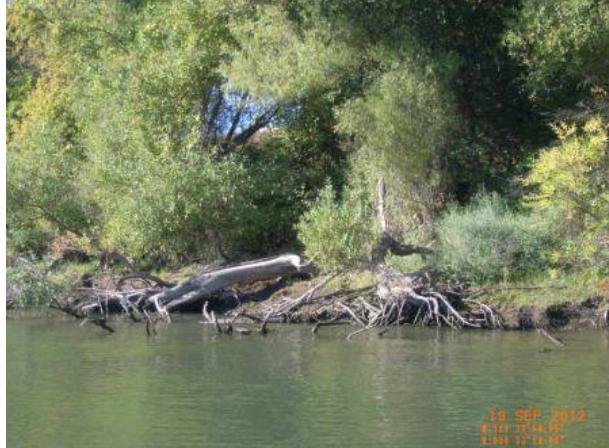
USACE 2012 Photo #2

Levee Mile Report Line	11
Start Levee Mile	2.35
End Levee Mile	2.49
Location	Water Side
Category	Supplemental
Item	USACE Erosion Survey

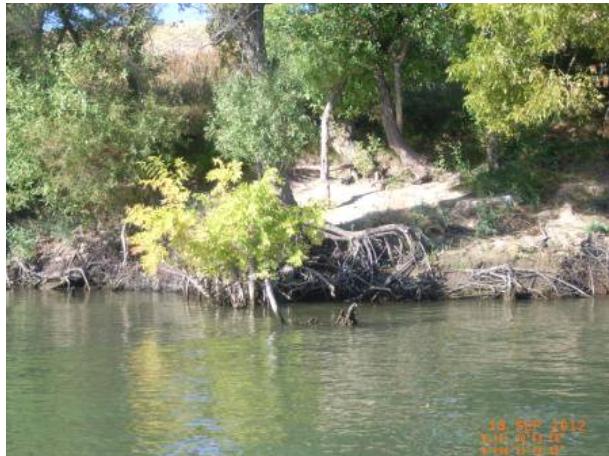
USACE 2012 Photo #3

Levee Mile Report Line	11
Start Levee Mile	2.35
End Levee Mile	2.49
Location	Water Side
Category	Supplemental
Item	USACE Erosion Survey

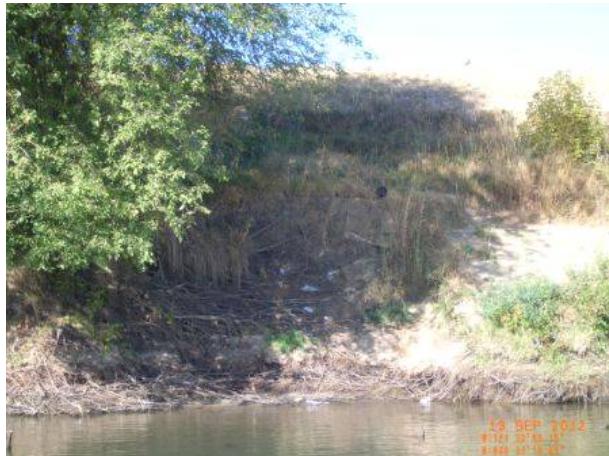
USACE 2012 Photo #4

Levee Mile Report Line	11
Start Levee Mile	2.35
End Levee Mile	2.49
Location	Water Side
Category	Supplemental
Item	USACE Erosion Survey

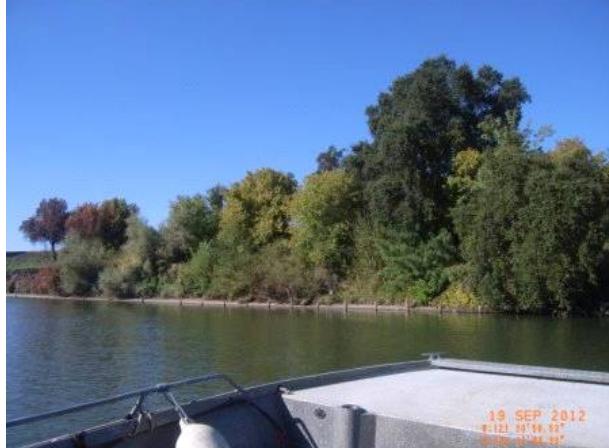
USACE 2012 Photo #1

Levee Mile Report Line	22
Start Levee Mile	2.56
End Levee Mile	2.65
Location	Water Side
Category	Supplemental
Item	USACE Erosion Survey

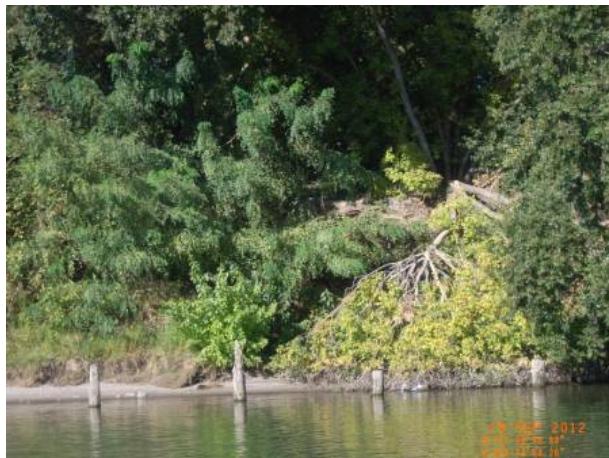
USACE 2012 Photo #2

Levee Mile Report Line	22
Start Levee Mile	2.56
End Levee Mile	2.65
Location	Water Side
Category	Supplemental
Item	USACE Erosion Survey

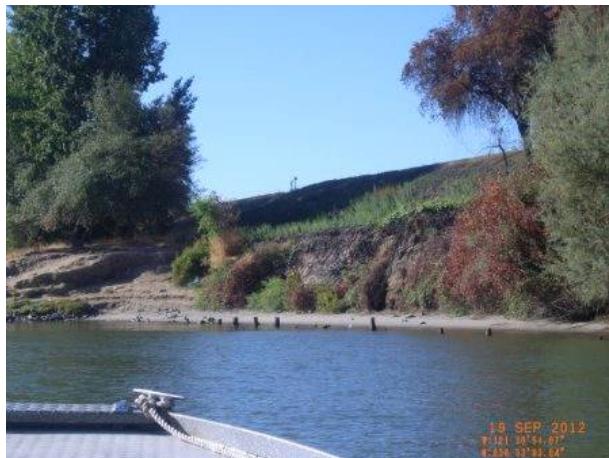
USACE 2012 Photo #3

Levee Mile Report Line	22
Start Levee Mile	2.56
End Levee Mile	2.65
Location	Water Side
Category	Supplemental
Item	USACE Erosion Survey

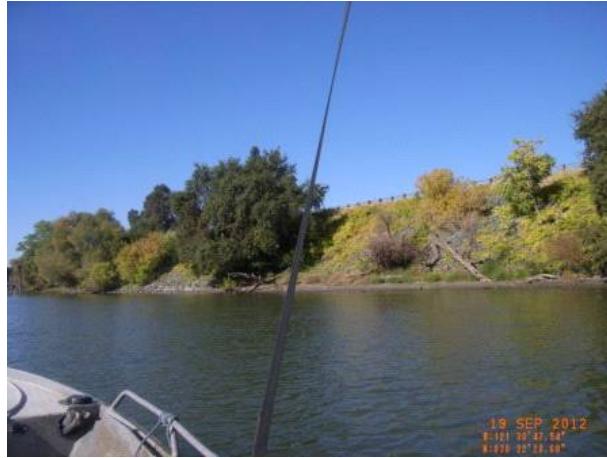
Levee Mile Report Line	33
Start Levee Mile	3.28
End Levee Mile	3.49
Location	Water Side
Category	Supplemental
Item	USACE Erosion Survey
USACE 2012 Photo #1	
USACE2012_SAC_55-7_R_1.jpg

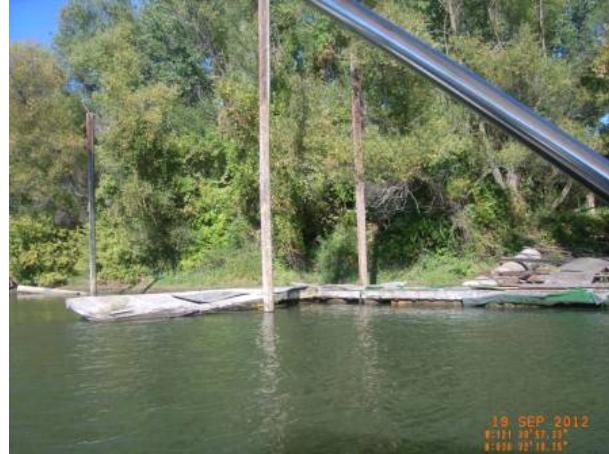
Levee Mile Report Line	33
Start Levee Mile	3.28
End Levee Mile	3.49
Location	Water Side
Category	Supplemental
Item	USACE Erosion Survey
USACE 2012 Photo #5	
USACE2012_SAC_55-7_R_5.jpg

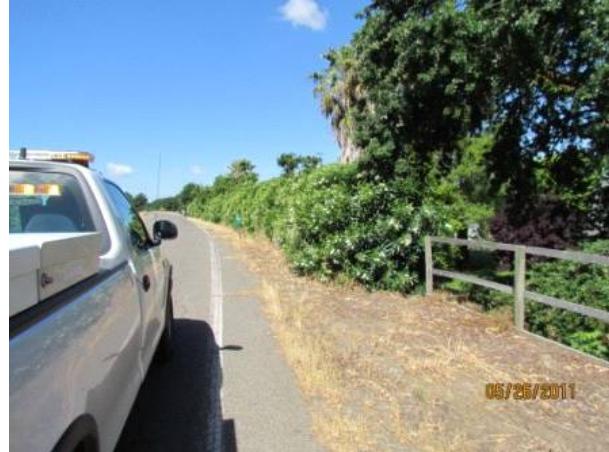
Levee Mile Report Line	75
Start Levee Mile	6.57
End Levee Mile	6.63
Location	Land Side
Category	Earthen Levee
Item	Vegetation
Landscaping was obstructing the view on the landside of the levee. The picture was taken from the crown looking downstream.	
pkazi_f_20120913_770.jpg

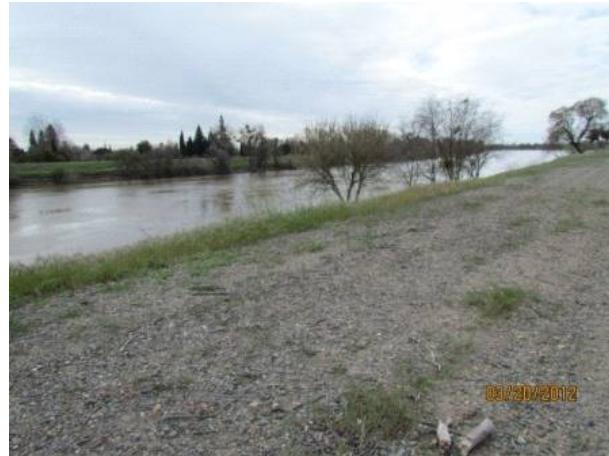
Levee Mile Report Line	81
Start Levee Mile	7.35
End Levee Mile	7.35
Location	Water Side
Category	Earthen Levee
Item	Encroachments
Prunings on the waterside of the levee was removed by the LMA. The picture was taken from the crown looking downstream.	
pkazi_f_20120913_776.jpg

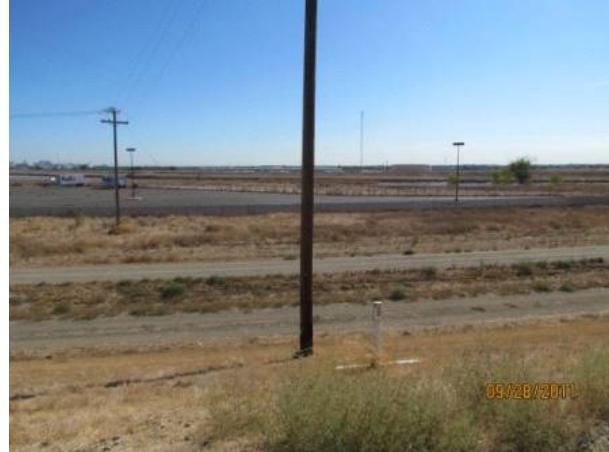
Levee Mile Report Line	10
Start Levee Mile	2.46
End Levee Mile	2.46
Location	Land Side
Category	Earthen Levee
Item	Encroachments
Wood pole for electrical lines was located on the landside of the levee. The picture was taken from the crown looking upstream.	pkazi_f_20120913_809.jpg

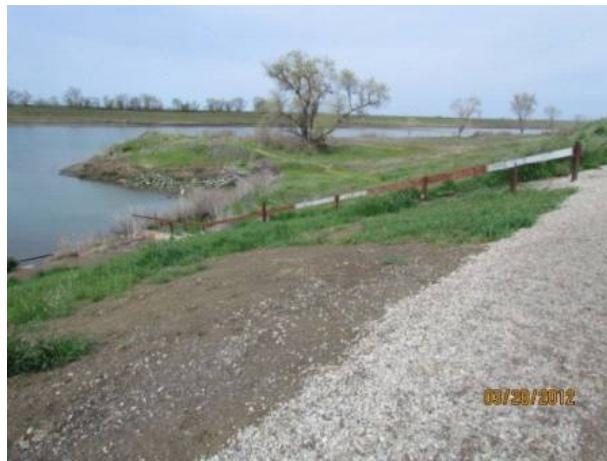
Levee Mile Report Line	16
Start Levee Mile	3.27
End Levee Mile	3.27
Location	Water Side
Category	Earthen Levee
Item	Encroachments
The LMA removed the existing pipe and restored the site on the waterside of the levee. The picture was taken from the crown looking upstream.	
pkazi_f_20120913_805.jpg

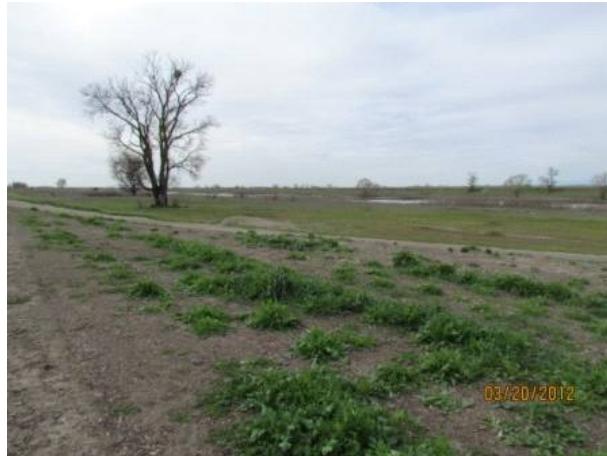
Levee Mile Report Line	21
Start Levee Mile	3.59
End Levee Mile	3.59
Location	Water Side
Category	Earthen Levee
Item	Encroachments
Concrete debris was removed by the LMA on the waterside of the levee looking downstream.	
pkazi_f_20120913_804.jpg

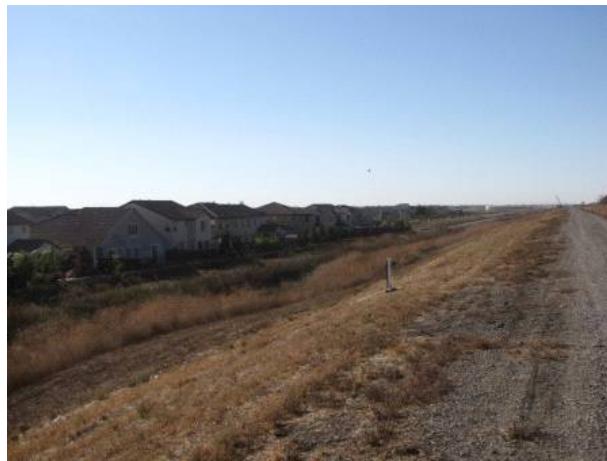
Levee Mile Report Line	25
Start Levee Mile	3.97
End Levee Mile	4.49
Location	Land Side
Category	Earthen Levee
Item	Vegetation
View of vegetation along the toe adjacent to the ditch looking downstream.	
pkazi_f_20120913_811.jpg

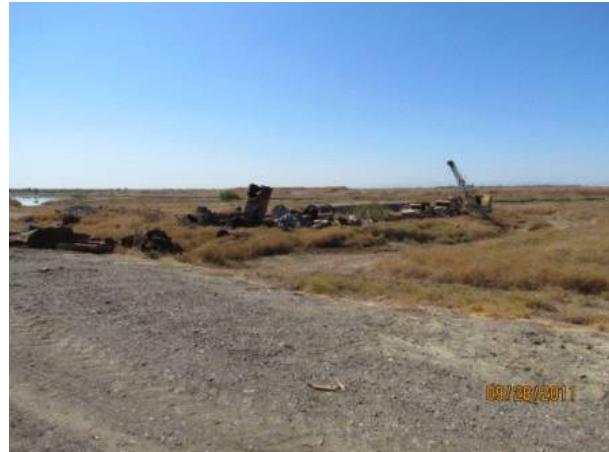
Levee Mile Report Line	26
Start Levee Mile	4.85
End Levee Mile	4.85
Location	Water Side
Category	Earthen Levee
Item	Encroachments
Metal equipments and debris are purposely placed next to the gate by the LMA for barricade. The picture was taken from the crown looking upstream.	
pkazi_f_20120913_818.jpg
